AN/ASQ-232 AIRBORNE MINE NEUTRALIZATION DEMONSTRATION (AMNS) IN VERY SHALLOW WATER (VSW)

Paul Moser
Naval Surface Warfare Center-Panama City
(NSWC-PC)

AN/ASQ-232 AMNS VSW Demonstration

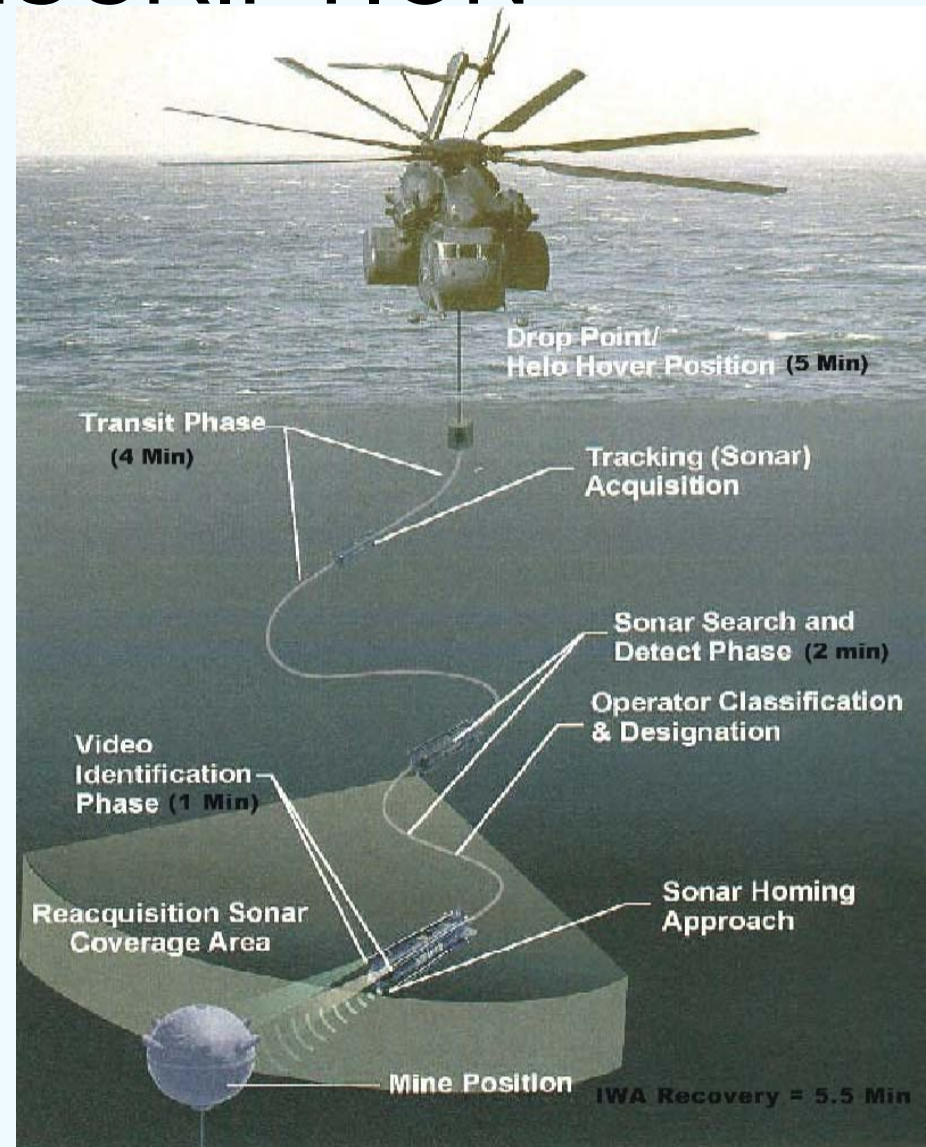
AN/ASQ-232 AMNS SYSTEM DESCRIPTION

- US NAVY SYSTEM FOR MINE NEUTRALIZATION IN PERMISSIVE ENVIRONMENT
- HELO LAUNCHED FROM MH-53
- ULTRA SHORT BASELINE TRACKING TO WAYPOINT
- ROTATING HEAD SONAR FOR TARGET ACQUISITION
- VIDEO FOR IDENTIFICATION
- SHAPE CHARGE FOR NEUTRALIZATION

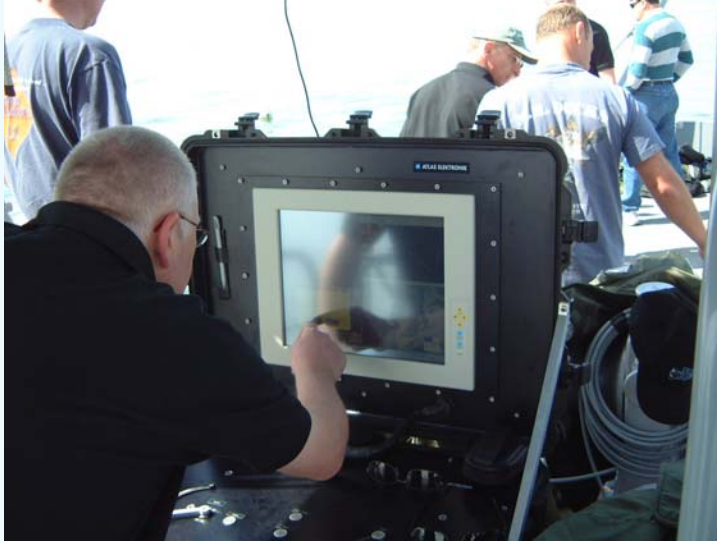
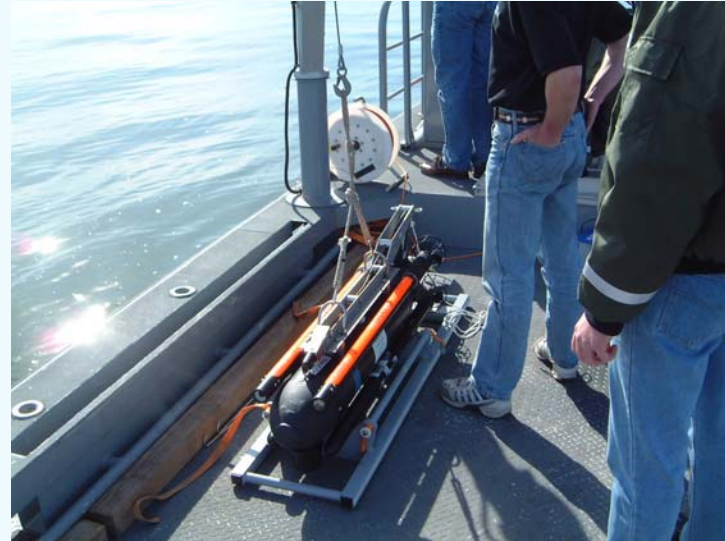
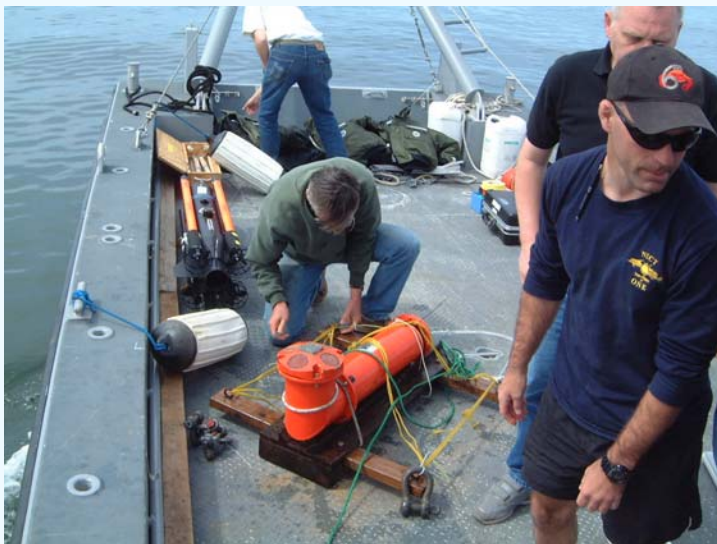
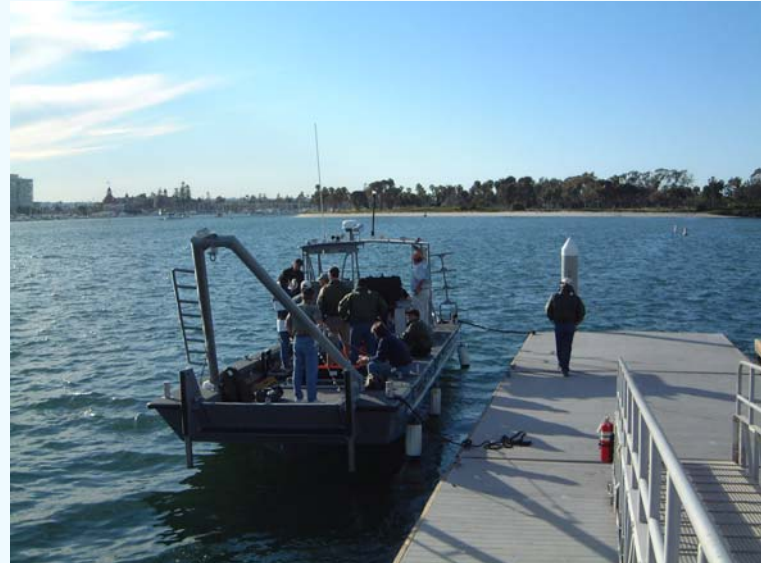
Demonstration Hardware

- Inert training neutralizers
- Portable Mobile Control Console
- Support Equipment
 - Mobile winch, tie down straps, interface cable, snap hook carry handles, 2-3 cradles, battery charger, 4 sets NiCad batteries
 - Neutralizer Test set
 - VGA-out Recording set
- NSCT-1 equipment
 - Workboat, 2 Mantas, and 1 Mal-17 buoyed off in 10-20 ft of water
- Acoustic Doppler Current Profiler for environmental Characterization
- Neutralizer placed within 25 yards of target

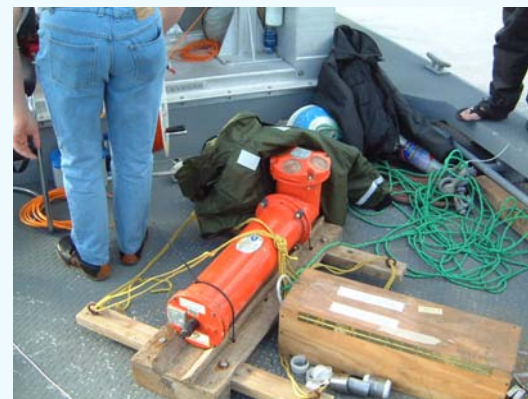
**Acoustic Doppler
Current Profiler
(ADCP)**

No	Description	Depth and Location	Coordinates
#1	Manta	30 ft on bottom	32°36.590 N & 117°08.305W
#2	MAL 17	21 water depth ft & 6 ft off bottom	32°36.592 N & 117°08.267W
#3	Manta	15 ft on bottom	32°36.598N & 117°08.262W
#4	ADCP	10 ft on bottom	32°36.587N & 117°08.229W

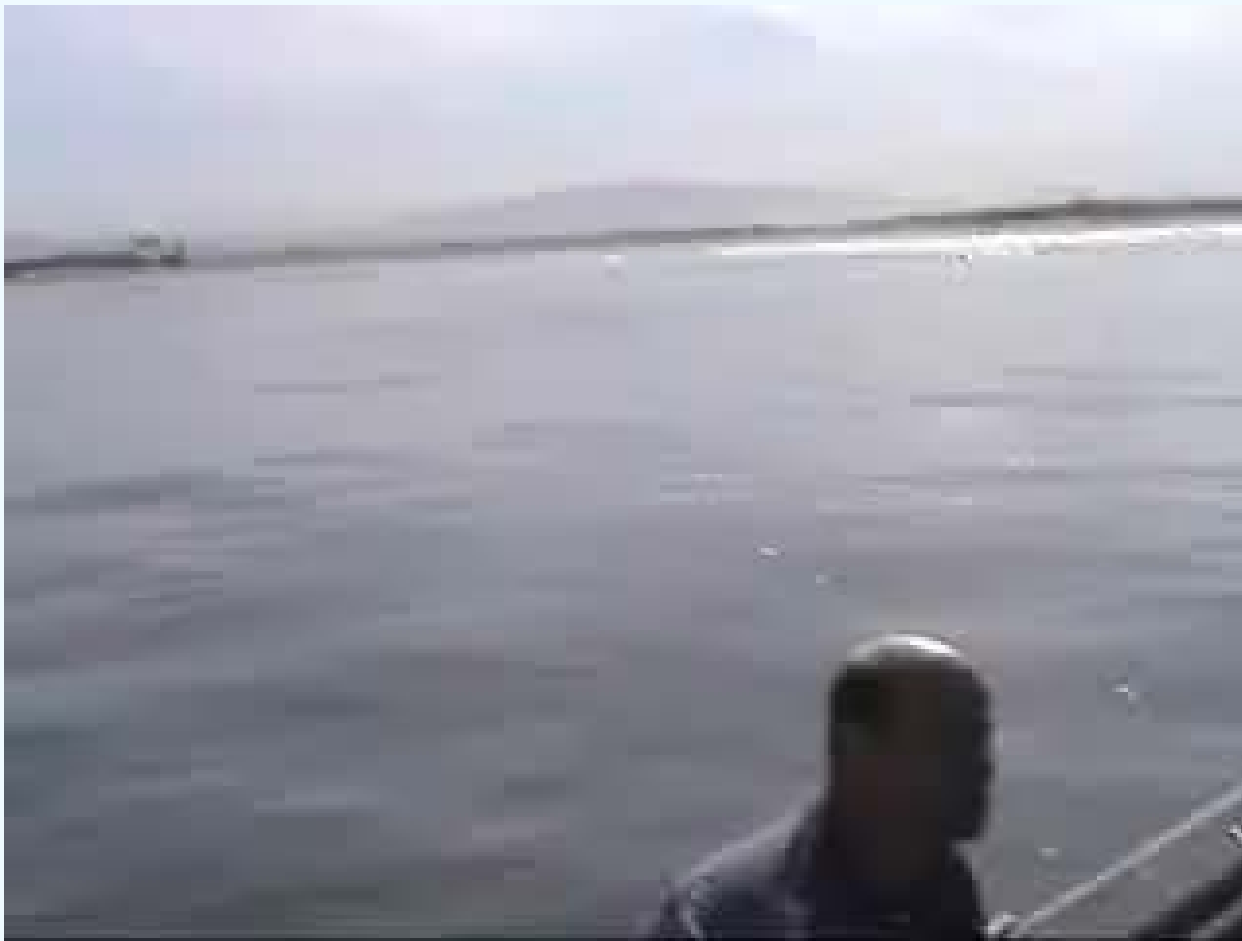
CONDITIONS: SEASTATE 0 ?

**Slight Swell, Waves breaking in 6-8 Feet of
Seawater**

- Seastate not enough info to Characterize conditions in VSW
- Test conducted before and after VSW test were positive-Only variable changed from dockside test was *Surge*
- Recommend additional technology development in the following areas:
 - Vehicle control
 - Improve Target Location/Sonar Detection
